ESG ENVIRONMENTAL DUE DILIGENCE REPORT

Decarbonisation Strategy | ESG Environmental Due Diligence Report

2. Introduction

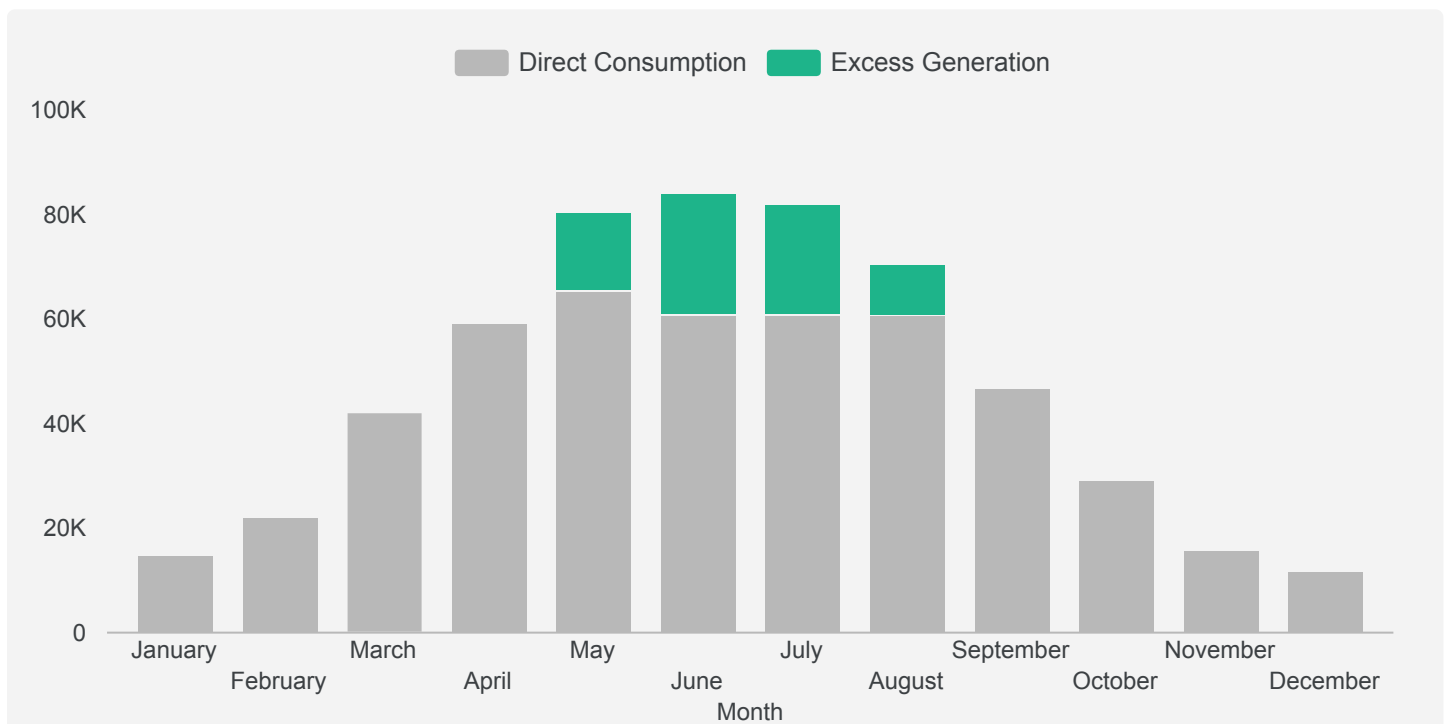
4.2. Solar Generation (kWh)

- The proposed system would utilise 4,767 m² of roof space across 20 segments, installing 1,940 panels.
- Total capacity is estimated at 660 kWp, with expected annual generation of ~0.55 GWh (P90), based on an 85% performance ratio and 0.5% degradation.
- Existing site demand is approximately 725,146 kWh/year, with a further 112,320 kWh/year expected from the proposed heat pump.
- Combined future demand is ~0.84 GWh/year.

Solar generation from May to August exceeds on-site use, resulting in export potential during summer months, while generation during winter is fully utilised on-site with no excess exported.

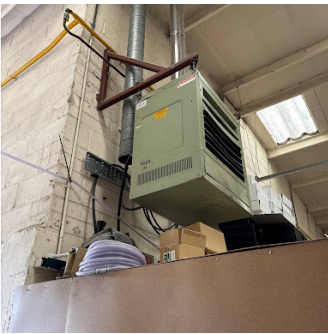
Gas Fan Heater

Direct-fired gas fan heaters were observed in Units 1, 3-4 and Unit 8, providing space heating for the warehouse areas. Combi boilers for domestic hot water were noted in Units 1, 3-4, 6 and Unit 8. Unit 2 has decommissioned all gas systems and operates without heating, while Unit 9 has no gas or heating provision. Unit 7 operates entirely on electric systems with 24/7 electric cookers.

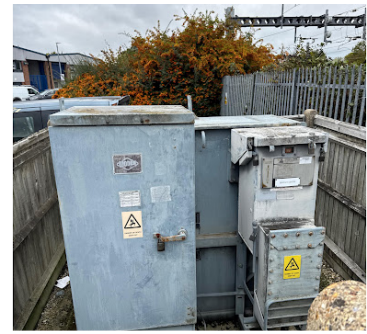
Electrical Equipment

The electrical supply infrastructure was observed to have capacity limitations across multiple units. Unit 9 experiences frequent power trips, Unit 7 has insufficient power capacity and is seeking supply upgrades, and Unit 6 was noted to have a basic supply of electricity. Unit 8 was identified as having very high energy consumption alongside Unit 7.

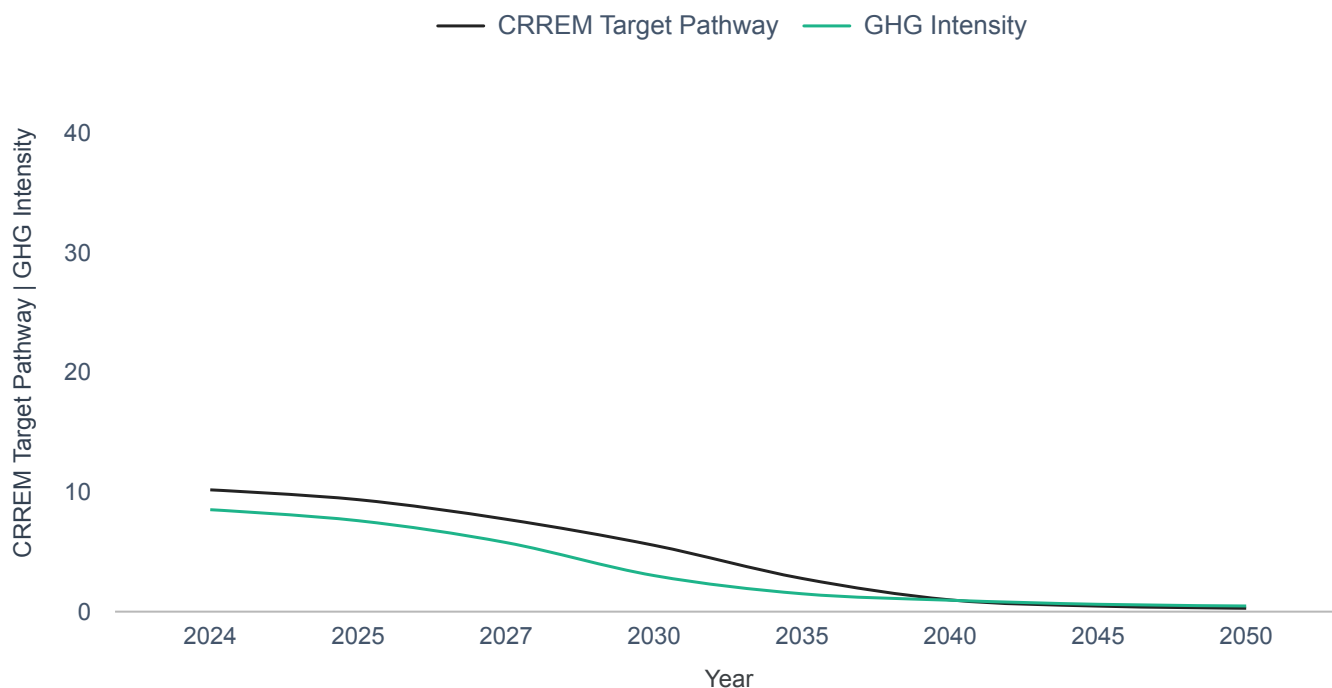
Annual GHG Intensity Trend and CRREM Alignment Pathway ($\text{kgCO}_2\text{e/m}^2\text{/yr}$)

The Combined Heat and Solar measure achieves immediate CRREM pathway alignment through integrated heat electrification and renewable generation, delivering 75% emissions reduction versus baseline. Carbon intensity of $7.52 \text{ kgCO}_2\text{e/m}^2$ in 2025 provides a comfortable buffer 19% below the $9.28 \text{ kgCO}_2\text{e/m}^2$ pathway target, eliminating stranding risk and enabling access to green financing mechanisms. With works assumed complete by 2028, the asset is projected to achieve net zero carbon intensity approximately 12 years ahead of the 2040 CRREM pathway target, significantly eliminating stranding risk and positioning the asset well ahead of regulatory requirements.

The Combined Heat and Solar measure implements an integrated decarbonisation strategy combining both heat pump installation and rooftop solar PV deployment across the estate. This comprehensive approach includes replacing all gas-fired heating systems with Air Source Heat Pumps alongside the installation of solar PVs, creating operational synergies where electrified heating loads increase on-site renewable energy utilisation. The scenario represents full electrification of building energy systems with substantial renewable generation.
